**Roof Condition Report  
For  
Dinas Powys Parish Hall**

Written by Nathan Goss Conservation

Issued to Dinas Powys Community Council

## Roof Condition

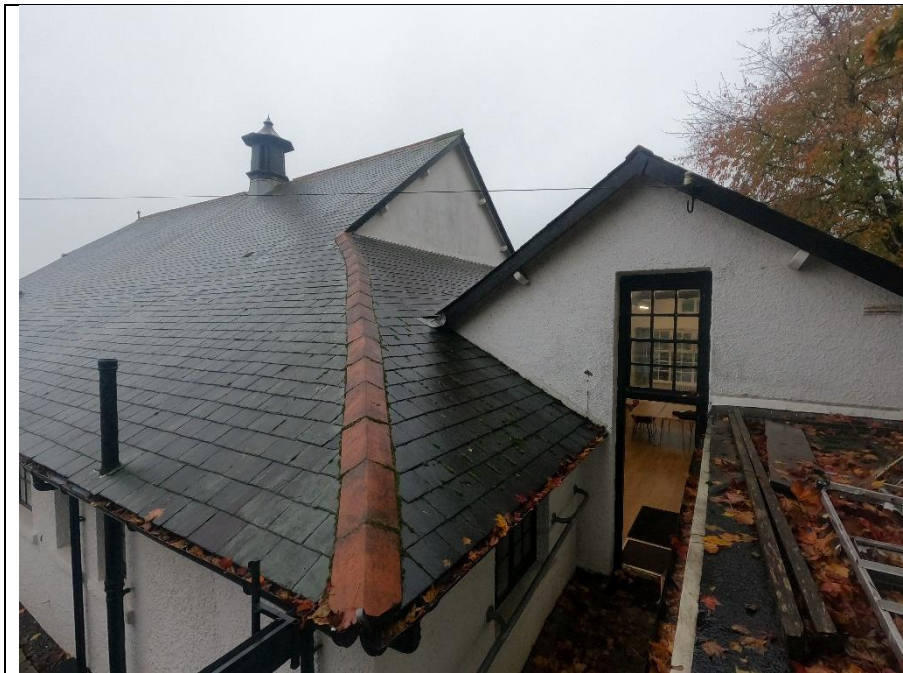
Figure 1 - A view west at the north roof

The north elevation has been re-roofed at some stage as there is a different slate (maybe Spanish or Chinese). There are quite a few slipped slates in this area, which are evident in the lead valley, also the lead flashing to the gable has lifted and is exposing the top course of slate.

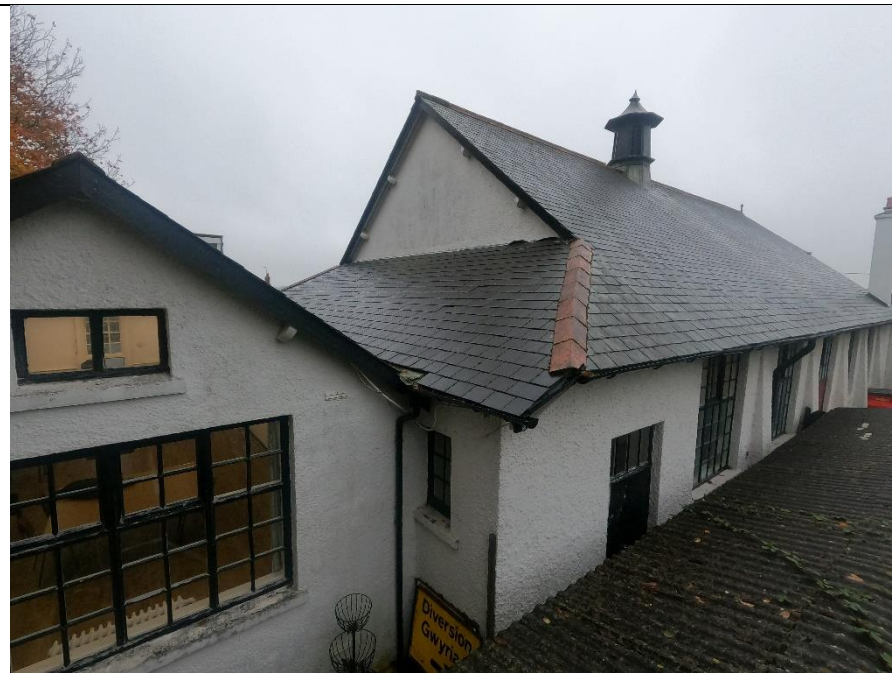
Figure 2 - A view east at the north roof

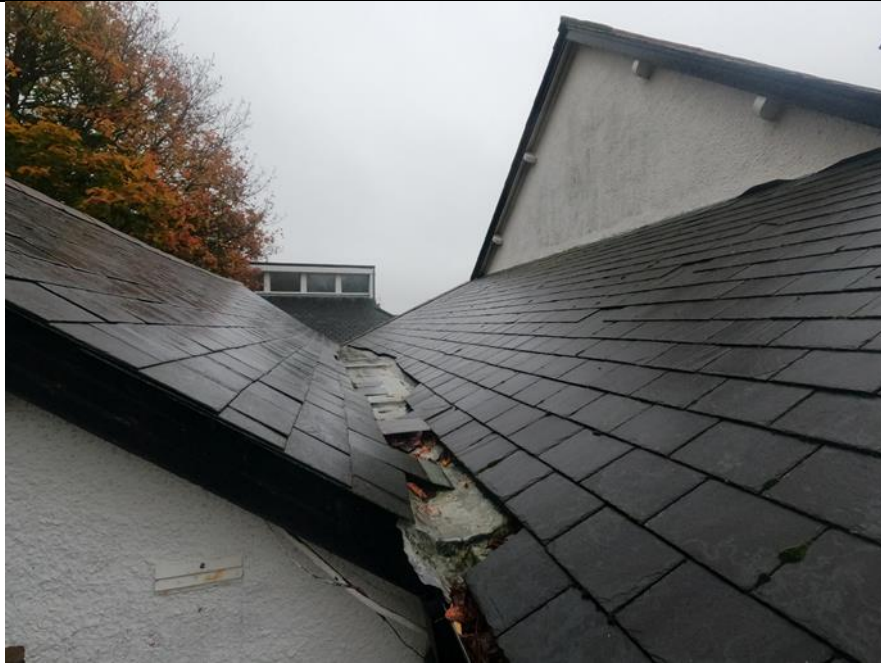
**Figure 3 - Valley between north roof and rear building**

Broken and missing slates are quite evident on both elevations either side of the valley, the rear building (fig 4) is showing signs of iron pyrites, there are two types of iron pyrites stable and unstable - unstable pyrites which are only found in cheaper softer slates (Spanish/Chinese/Brazil) tend to break down a lot quicker than stable pyrites. As this section of roof has only been reroofed recently (probably within the last 20 years) it suggests that imported soft slate has been used. To note Welsh slate can sometimes have pyrites within its structure but these are of the stable nature, pyrites do not affect the harder slate (classed as T1 slates). The lead valley that straddles the two roofs is in poor condition.

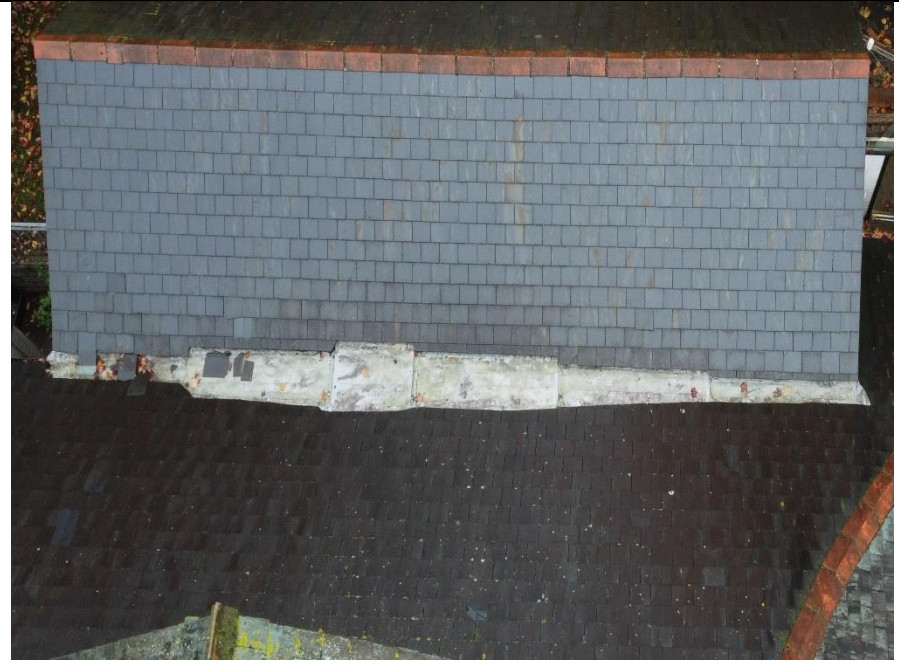
**Figure 4 - Arial shot of lead valley**

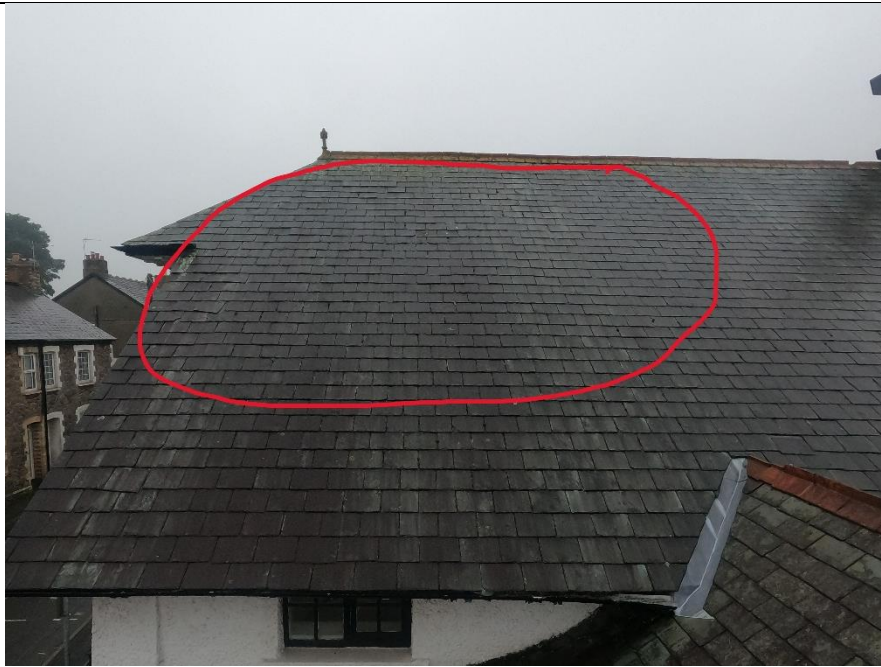
**Figure 5 – Large loose area of slate**

The east elevation has large areas of slate that are unstable, some sections are slipping, broken and are kicking up from the lack of fixing. This elevation is in the worst condition and could cause considerable problems during high winds and should be monitored regularly. The clay ridges all along the apex of the roof are losing their pointing and perhaps even mortar, there are signs that some of the ridges are not originals to the building (2no by ventilation turret), some are also being held together by cement flaunching.

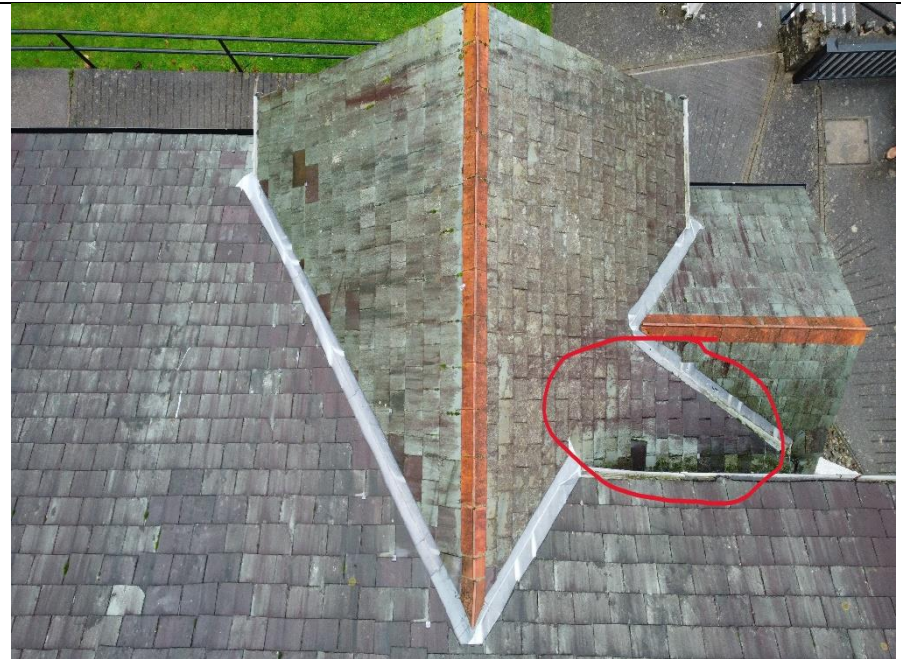
**Figure 6 - Loose and broken slate**

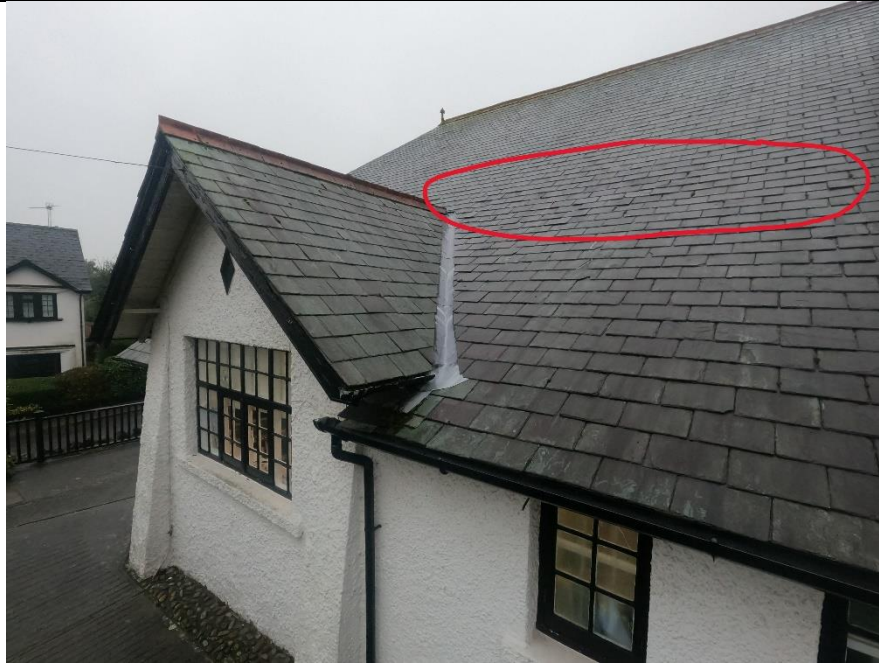
**Figure 7 - Large area of loose and unstable slate**

The lower section of roof (which seems to line up with the office ridge) has a long thin strip of loose unstable slate this stretches from the south gable (front) to the north gable (rear). The lead valleys to the main office and porch area seem to be in good condition, there is evidence internally that they have been replaced.

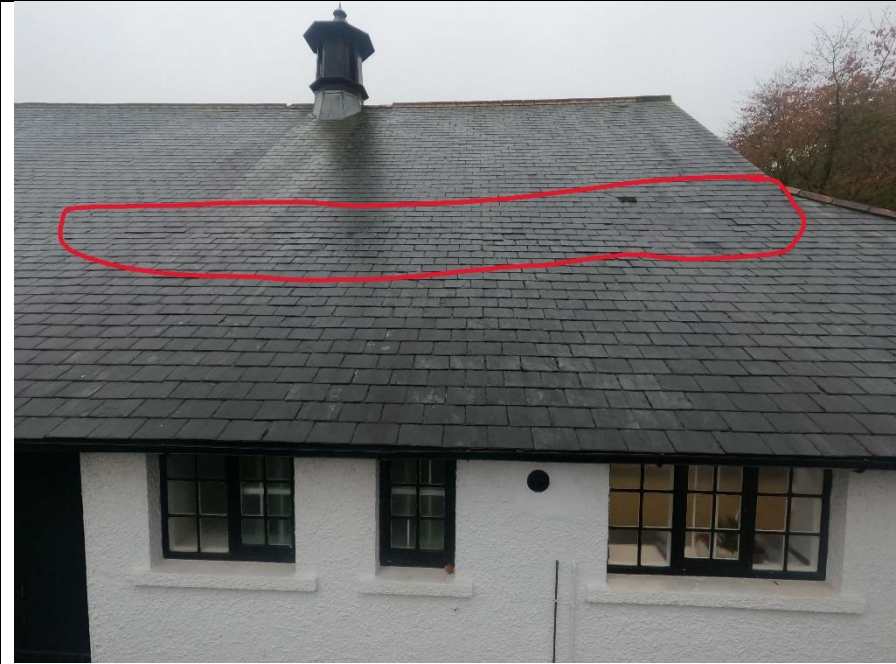
**Figure 8 - Large area of unstable and loose slate**

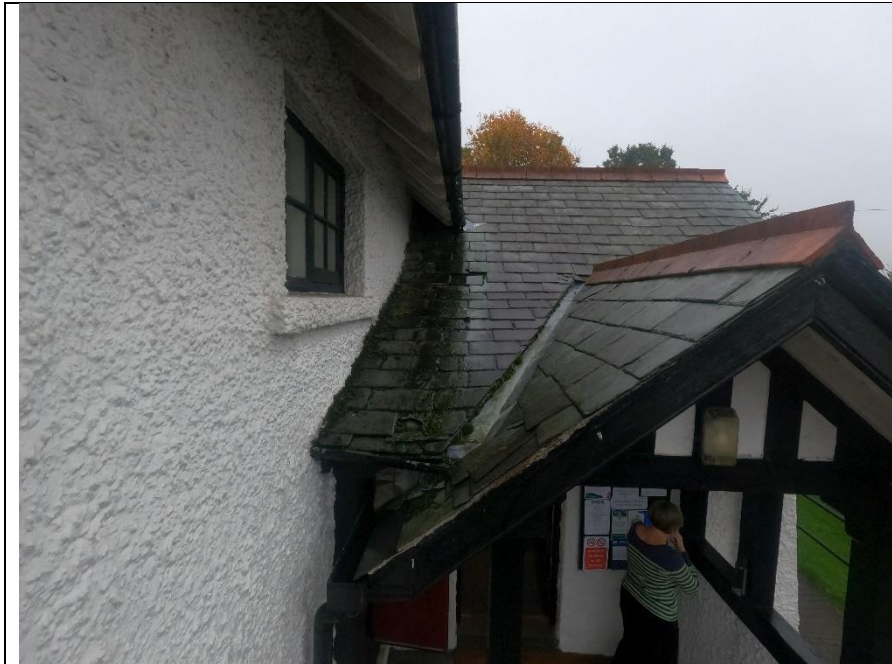
**Figure 9 - Section of roof over office and porch**

The section of roof over the office and porch has quite a few loose and broken slates, the lead doesn't look like it's been replaced and is in poor condition.

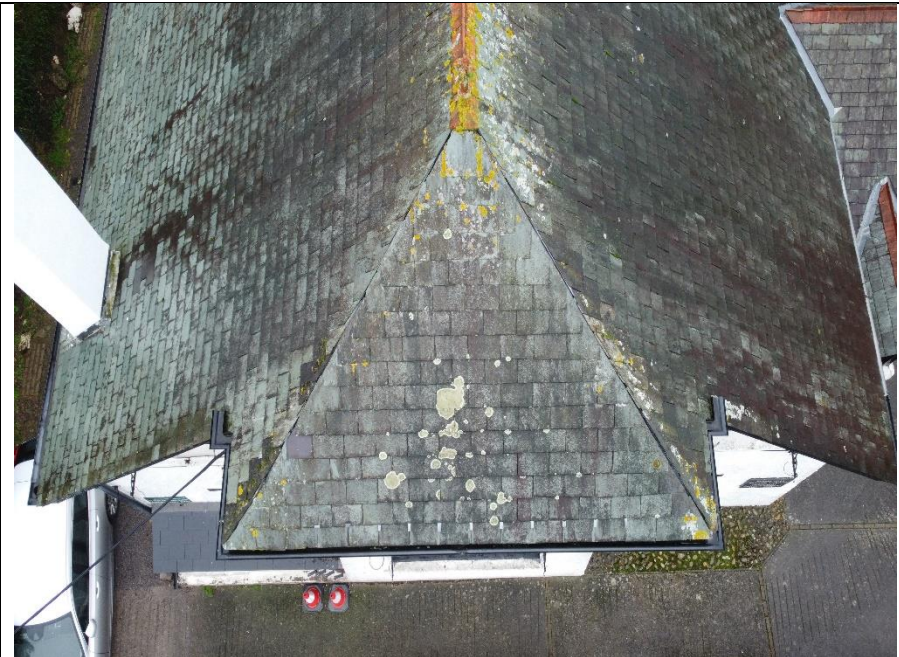
**Figure 10 - Small hip roof above bay window**

The small, hipped roof over the bay window has a row of loose slates right at its base, there are a number of lead tingles (Fixing straps) which are all laying in the wrong direction (Fig 11)

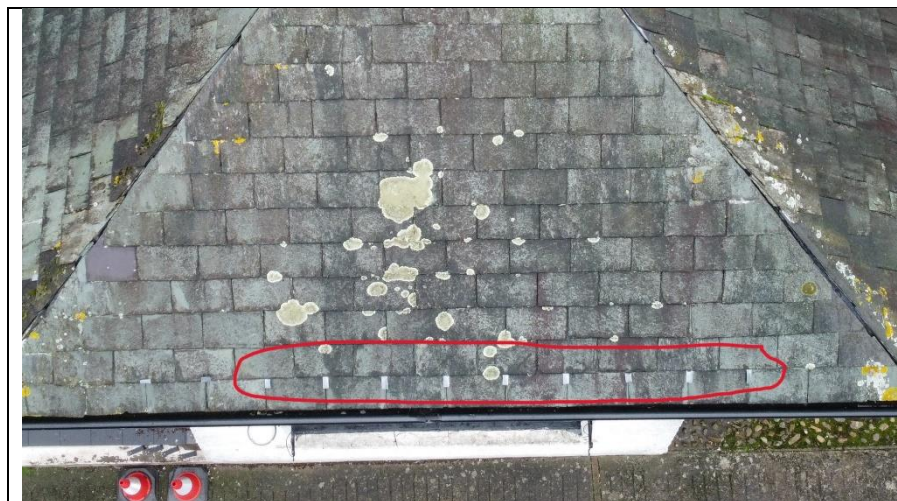
**Figure 11 - Lead tangles**

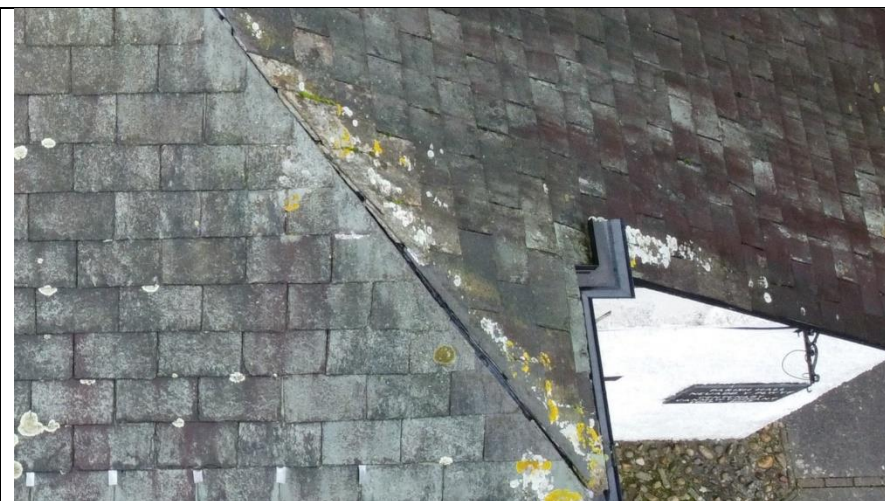
**Figure 12 - Open hip joints**

The slate hip joints are quite wide, open, damaged and could in the future cause a problem, this will only occur when the lead detail underneath the slates breaks down (Fig.27). There are quite a few loose slates either side of the hips, which need attention.

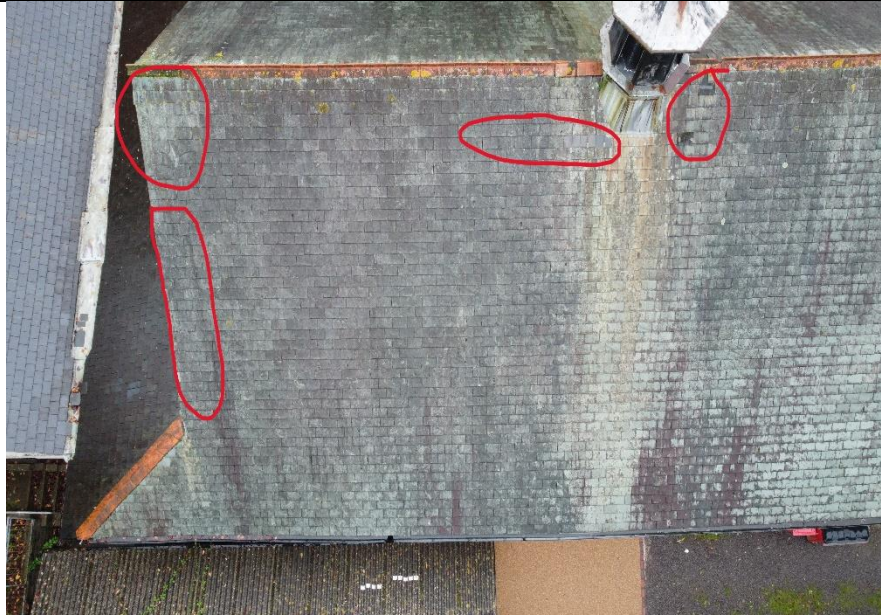
**Figure 13 - Loose and/or broken slate**

The West elevation is by far in the best condition, there are a few loose slates (fig 13) towards the rear of the building and around the ventilation turret. There are also a few slipped and broken slates around the chimney and hip. The majority of the roof is laying flat and has no external defects.

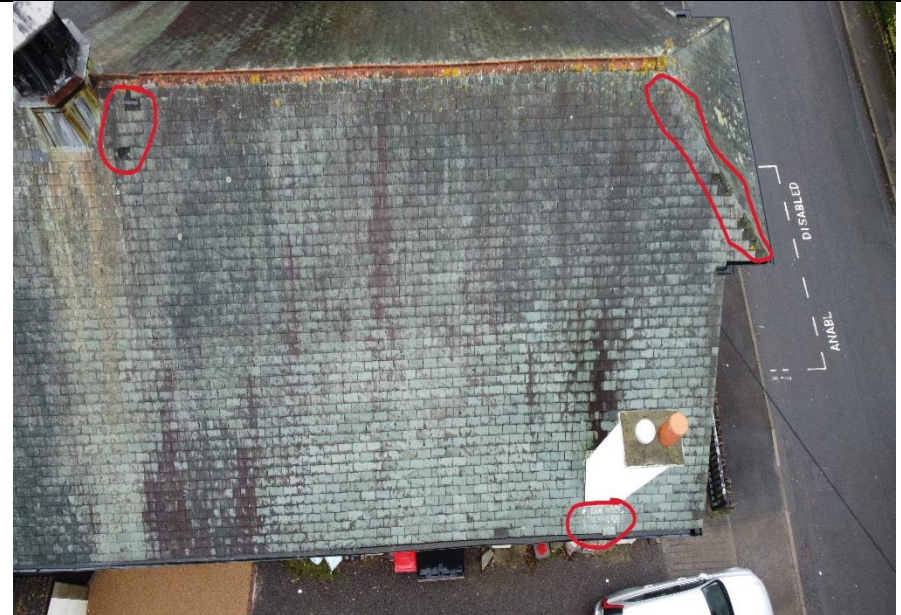
**Figure 14 - Slipped and/or broken slate**

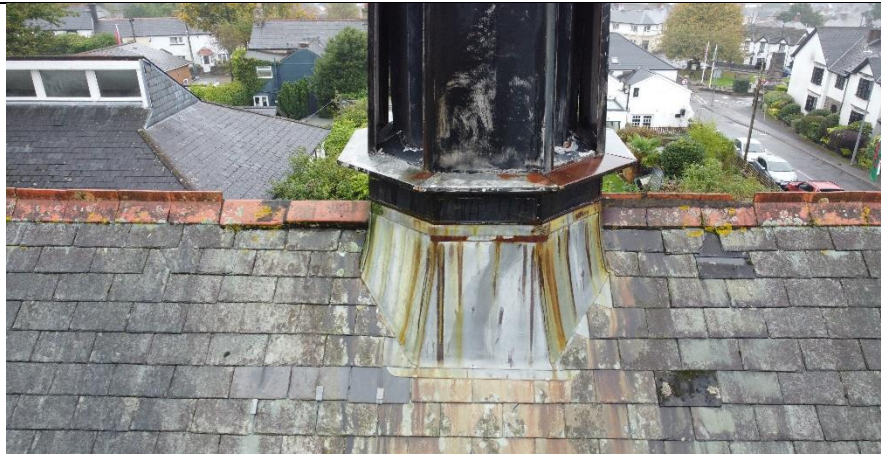
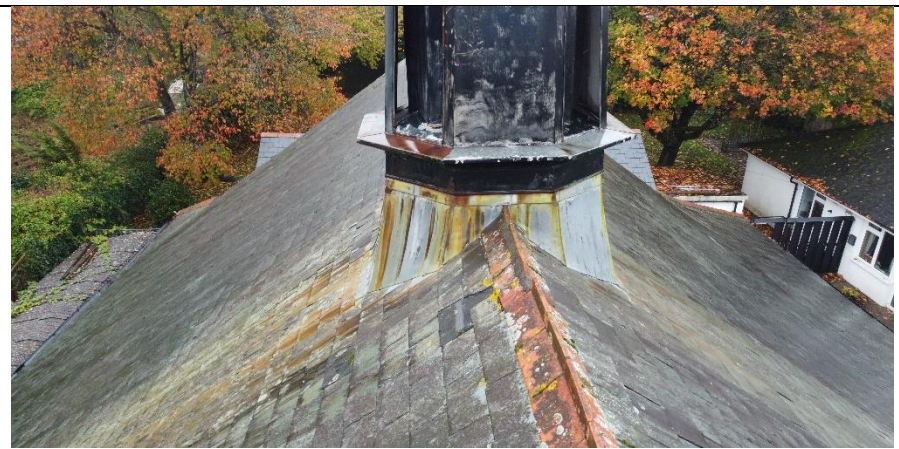
The ventilation turret is showing signs of deterioration and defects, there seems to have been some remedial work carried out previously (fig 15 different ridges and lead tingles), the slate all around the turret seems to be either broken, slipping or damaged in some way. In fig 15 & 18 you can also see the cement flashing holding the ridges together

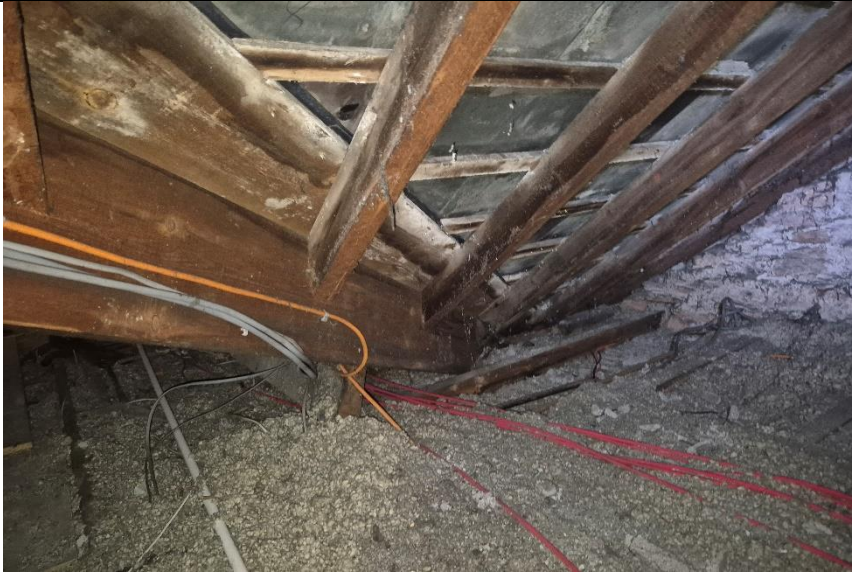
**Figure 21 - Above office**

There is some water staining on the valley board in Fig 21, you can also see some slate delamination in Fig 22 plus broken slates allowing light into the attic.

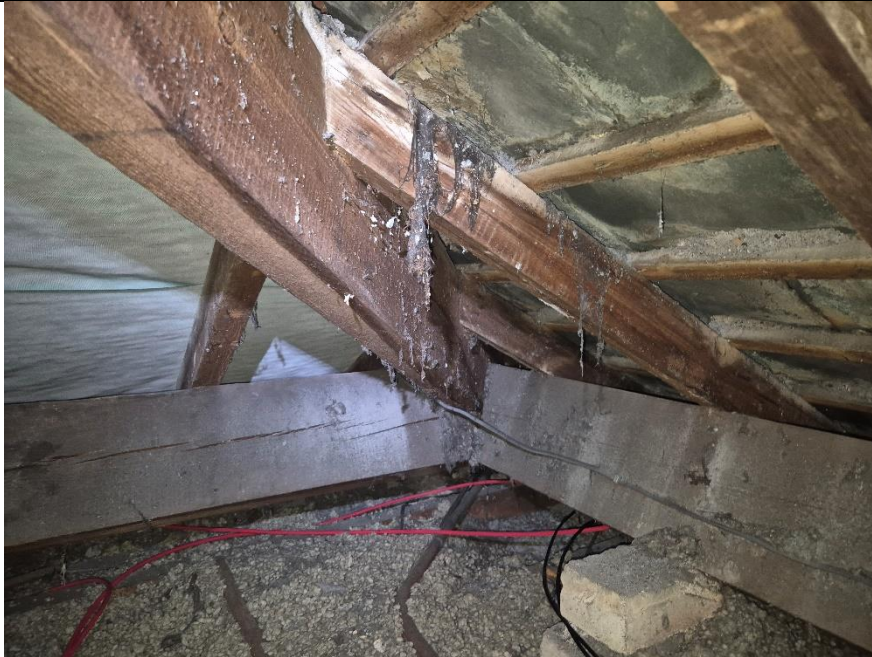
In Fig 23 and 24 it is evident that a new breathable membrane (Tyvek) was fitted when this section of roof was re slated, this is quite standard practice and is good for the building. In Fig 23 there is some signs of water damage to one of the jack rafters (white fungus), there is also some slate delamination to the side of the rot.

**Figure 23 - North end (re-roof)**

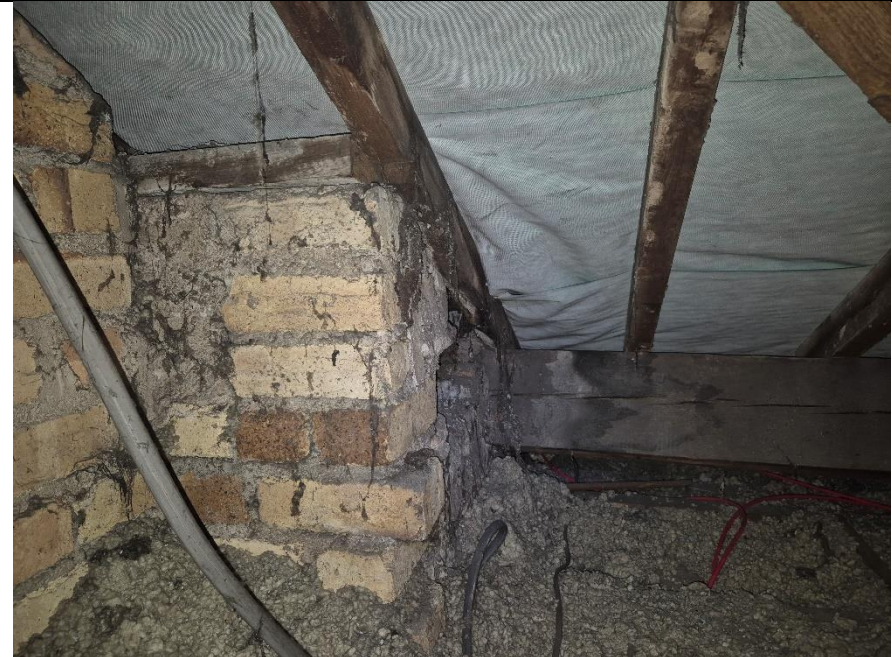
**Figure 24 - Tyvek breathable membrane to reroofed area**

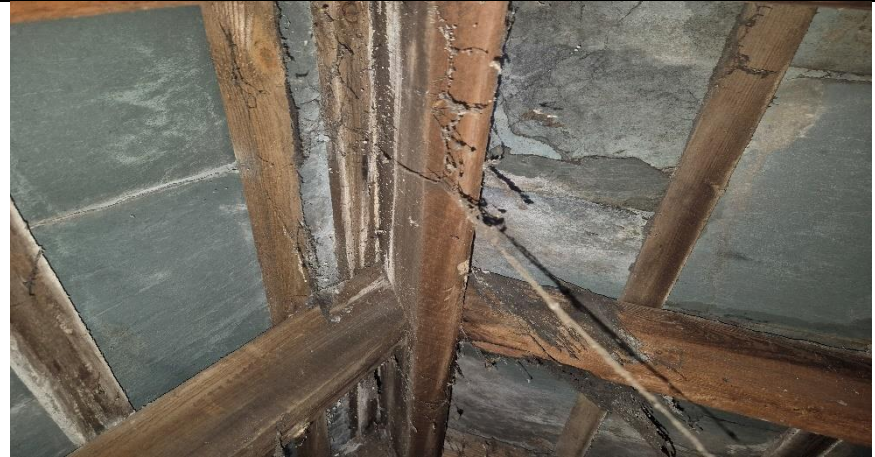
**Figure 26 - Delaminating slates at ridge**

The roof over the main hall is also suffering from nail fatigue and slate delamination (Fig. 26, 31 & 32) there is also a small amount of timber rot to the small hip (front) and along the length of the roofs ridge, otherwise the timber work is in remarkable condition for its age. There is some water ingress around the air box vent (Fig 33 & 34) this is predominantly to the west side, where you can see the defects in the roof in Fig. 15. The vent box is also fully packed with twigs, moss and other foliage from the crows nesting in the turret, this is preventing airflow throughout the attic and exacerbating the problems.

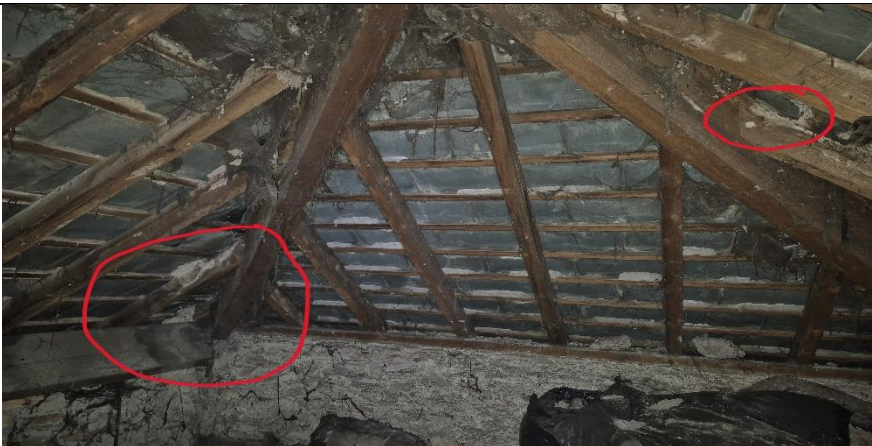
**Figure 27 - Water ingress at hip (See fig 12)**

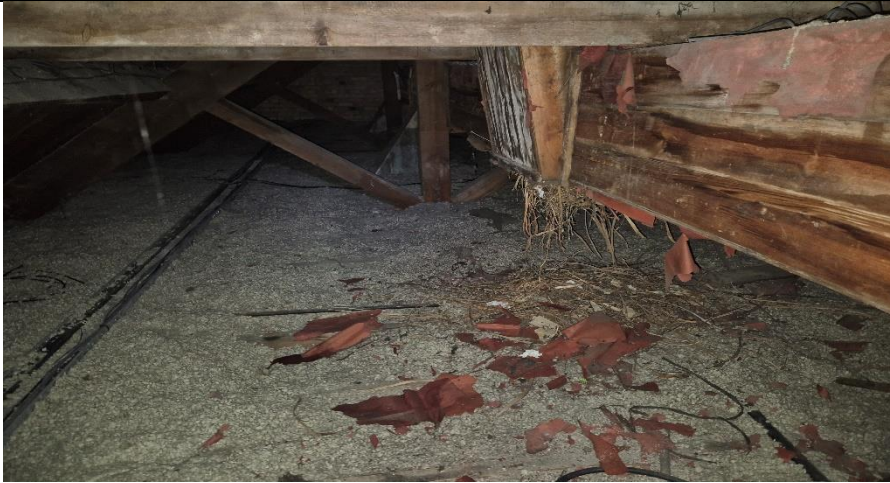
**Figure 29 - Crows nests in air box vent**

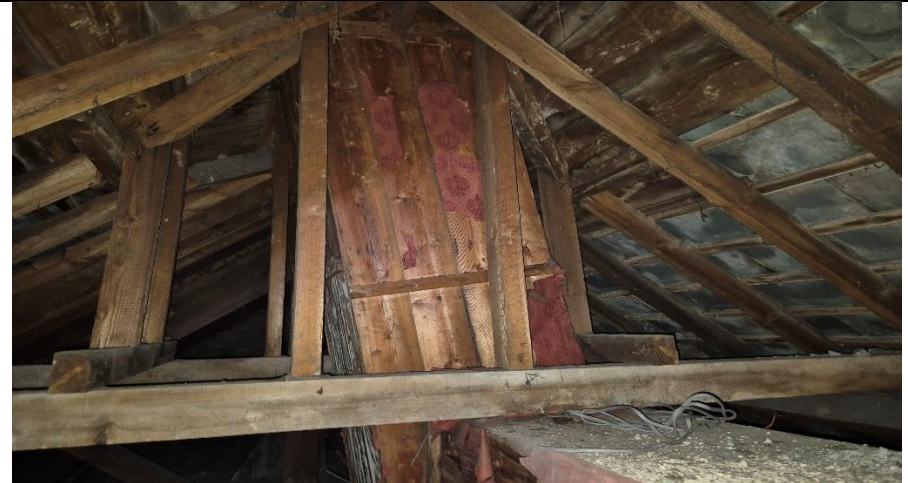
**Figure 30 - Wall paper on air box vent**

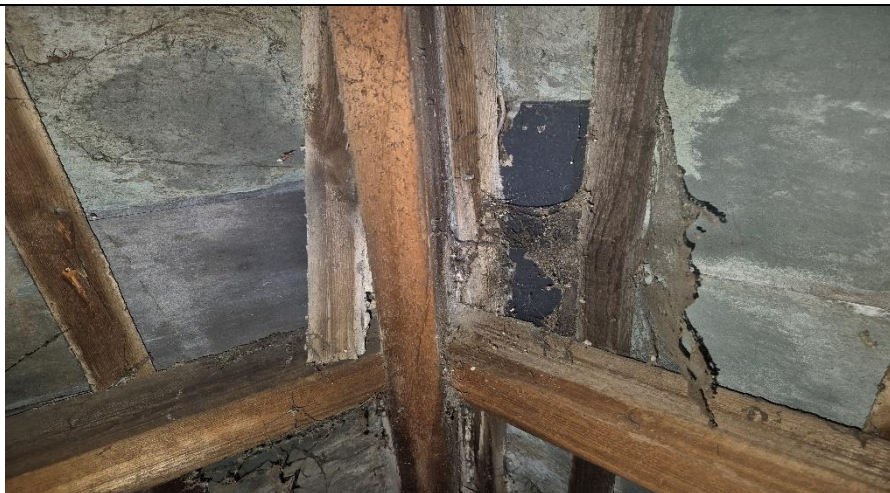
**Figure 31 - Slate delamination & timber rot at ridge**

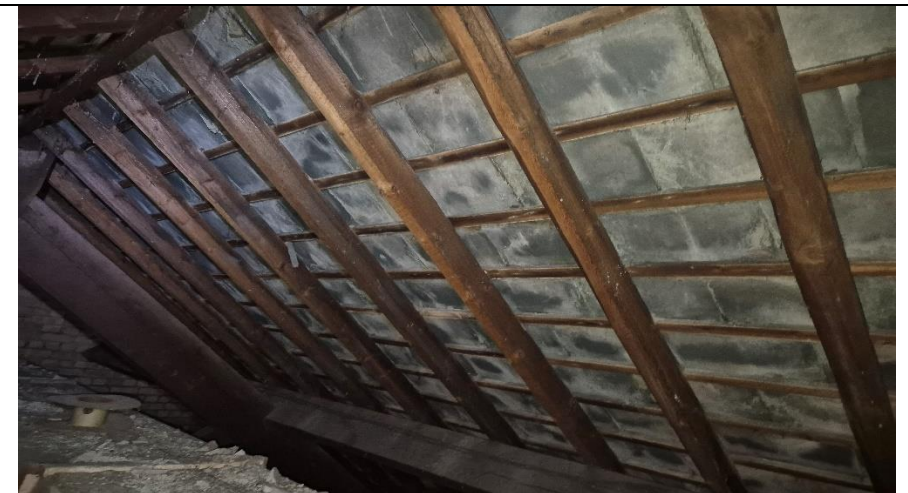
**Figure 32 - Slate delamination**

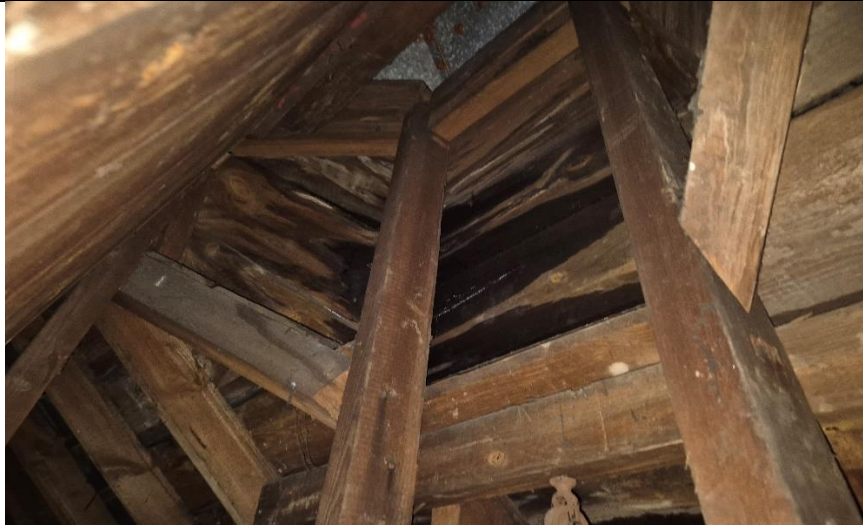
**Figure 33 - Water ingress to west side of vent box**

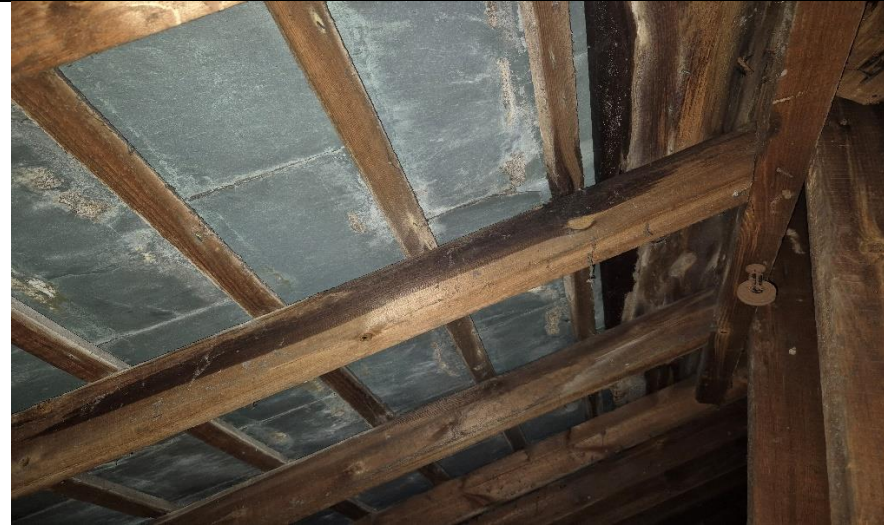
**Figure 34 - Water ingress below vent box**
