**Roof Condition Report  
For  
Dinas Powys Parish Hall**

Written by Nathan Goss Conservation

Issued to Dinas Powys Community Council

## Roof Condition

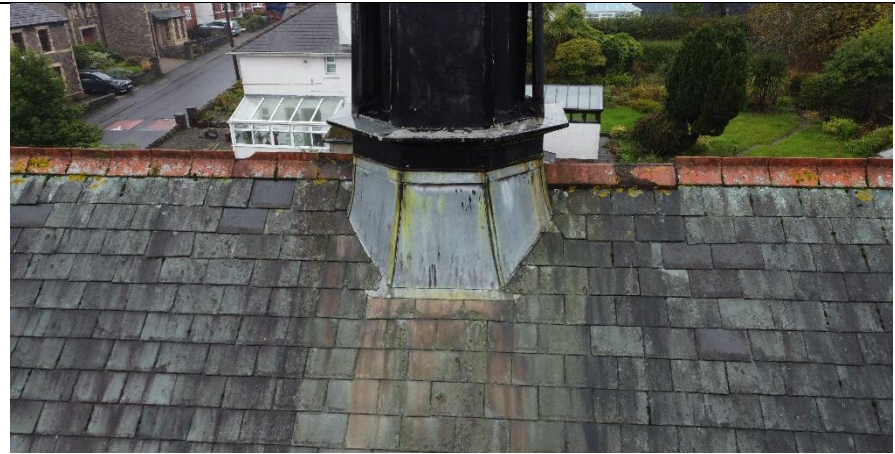
Figure 16 - Looking west

The ventilation turret is showing signs of deterioration and defects, there seems to have been some remedial work carried out previously (fig 15 different ridges and lead tingles), the slate all around the turret seems to be either broken, slipping or damaged in some way. In fig 15 & 18 you can also see the cement flashing holding the ridges together

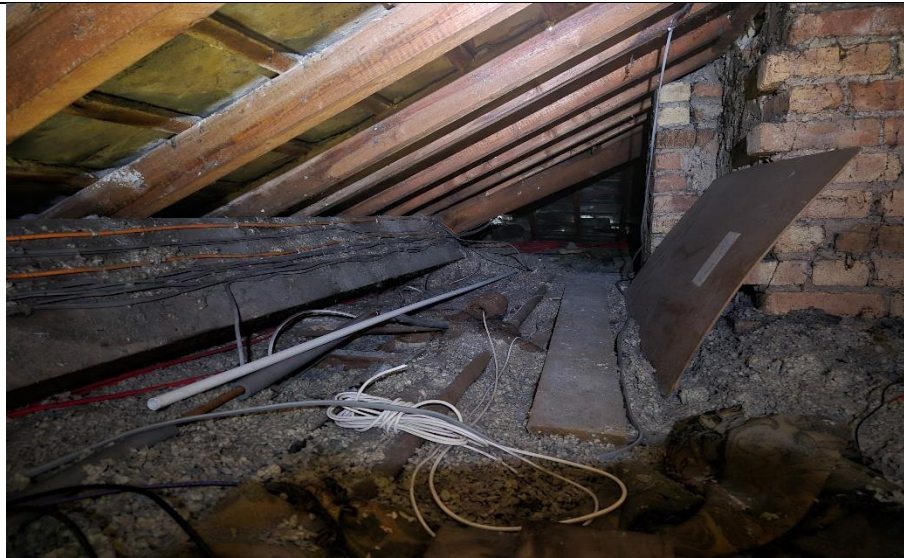
**Figure 19 - Above toilets looking south**

To the small attic space above the toilets, office and kitchen there is blown insulation, a lot of loose cabling and pipework. The timber work in the whole area is in remarkable condition.

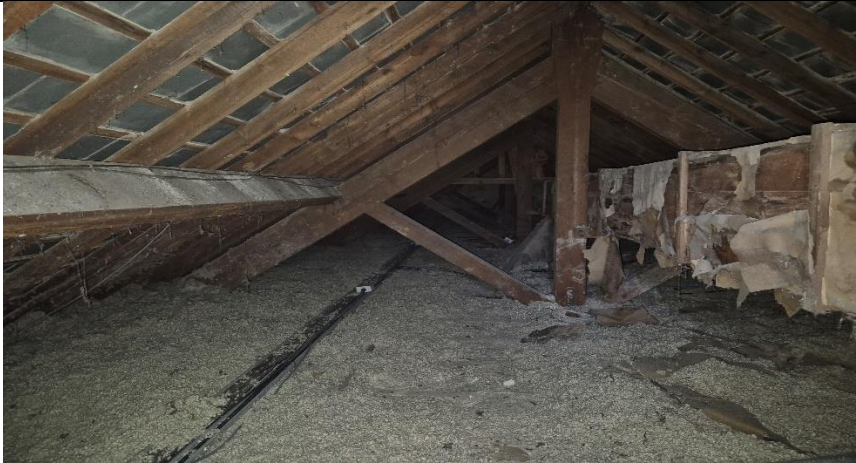
**Figure 25 - Looking north**

The roof over the main hall is also suffering from nail fatigue and slate delamination (Fig. 26, 31 & 32) there is also a small amount of timber rot to the small hip (front) and along the length of the roofs ridge, otherwise the timber work is in remarkable condition for its age. There is some water ingress around the air box vent (Fig 33 & 34) this is predominantly to the west side, where you can see the defects in the roof in Fig. 15. The vent box is also fully packed with twigs, moss and other foliage from the crows nesting in the turret, this is preventing airflow throughout the attic and exacerbating the problems.
