# Remediation Strategy Report

Site: The Cruz Dinas Powys

**REPORT TITLE** : **Remediation Strategy Report: Investigation of their former site compound off Ffordd Merrett, Dinas Powys CF64 4RH.**

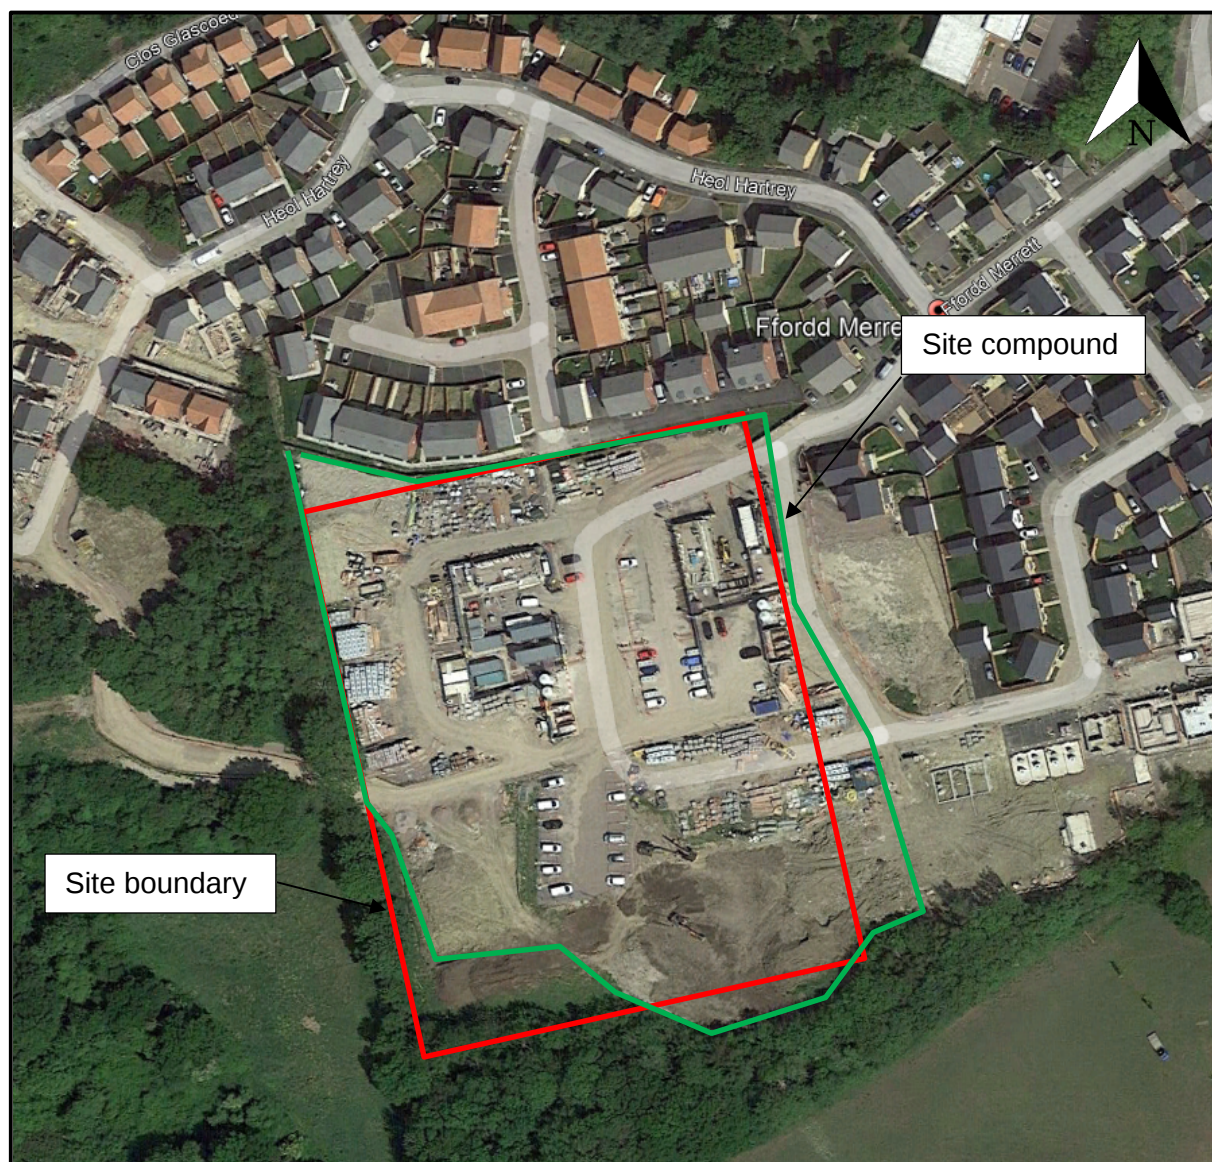
**Figure 2.2 Approximate Extent of Former Site Compound**

An aerial image dated May 2020 is presented in **Figure 2.2**. The site was previously covered by a mixture of hardstanding along the access road into the northeast of the site, and compacted stone across the majority of the site providing a car park for contractors, storage areas for materials and plant, and site offices, and welfare. Vegetation covered the far southwest of the site.

The site location can be seen on **Figure 2.1**. and the approximate extent of the former site compound is presented on **Figure 2.2**.
